URGENT PRODUCT DEFECT ALERT

HeartMate 3™ LVAS Kit (Model: 106524INT)
(ARTG: 300895 & 443219)

HeartMate 3™ System Controller (Model: 106531INT)
(ARTG: 289763 & 443220)

TGA Reference: RC-2024-RN-00602-1

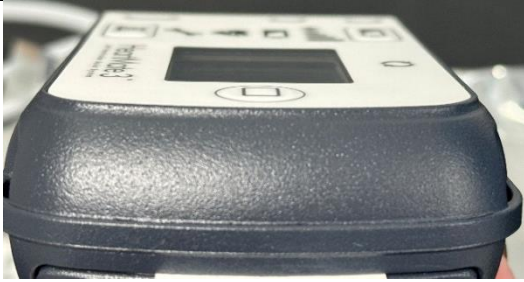
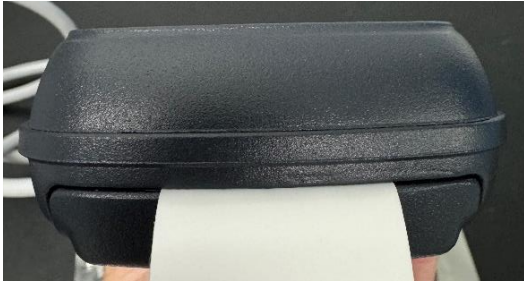
Abbott has identified that there is a potential for the controllers to have a lifted User Interface (UI) membrane that when present, is observed along the edge of the controller housing, near the Display Button as highlighted in images below. The product is not being removed from the field. As of June 25, 2024, Abbott had not received any complaints for this issue. Subsequently, Abbott communicated the possibility of this problem and provided initial instructions to customers to inspect Controllers for the UI membrane lift. As of July 8, 2024, after providing these instructions to inspect, Abbott has received 4 complaints where a lifted UI membrane was observed by customer with no patient harm reported. It is unlikely that any serious adverse health consequences would occur as a result of the lifted User Interface membrane as detailed below.

If the UI membrane is lifted and if the controller were to be exposed to fluid, there is a potential for fluid ingress into the controller which may lead to damaged Printed Circuit Board Assemblies (PCBA). This could result in unexpected and false positive alarms, as well as loss of the user interface (use of buttons, loss of visual alarms, etc.). Fluid ingress may also lead to loss of power to the pump resulting in a pump stop, however this possibility is very rare due to redundancies in the power path to the pump.

HeartMate 3 System Controller with <u>Lift</u> near the Display Button	HeartMate 3 System Controller with <u>no Lift</u> near the Display Button
Top Edge (close to Display button) View

- Carefully inspect the controller at the edge near the Display Button to confirm that the UI membrane is not lifted (refer to provided visual examples) prior to using the controller or providing the controller to your patient. Do not provide controllers with lifted UI membrane to your patients and report controllers with lifted UI membrane by contacting Abbott Technical Support at 1-800-456-1477 or your local Abbott Representative. Note that controllers that do not present a lifting UI membrane will not lift over time.

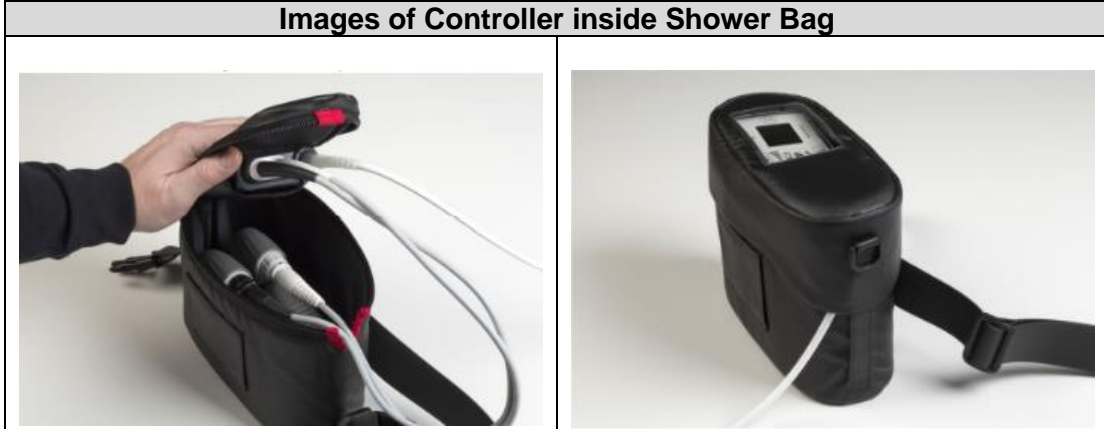
Appendix A – Image of Shower Bag

Refer to IFU and PHB pages 138-150 on how to use the Shower Bag and the image below of the Controller stored within the Shower Bag.

- Reinforce “General Warning” and “Warnings and Cautions” within the IFU and the PHB to protect the controller from exposure to fluids and keep it dry at all times. In addition, patients who are permitted to shower by a doctor, must use the Shower Bag for every shower. The Shower Bag protects the external system components from water and moisture. Refer to Appendix A for images of Shower Bag.
