URGENT MEDICAL DEVICE CORRECTION

HeartMate 3™ LVAS Kit (Model: 106524US)
HeartMate 3™ System Controller (Model: 106531US)
HeartMate 3™ System Controller Low Flow 2.0 (Model: 106531LF2)

July 2024

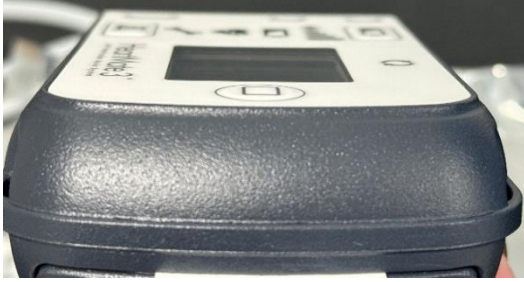
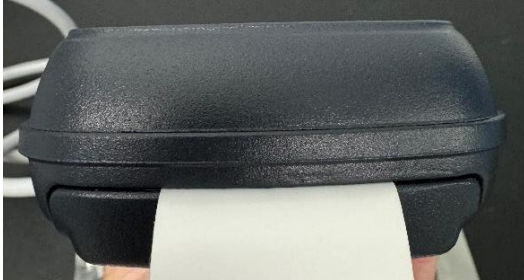
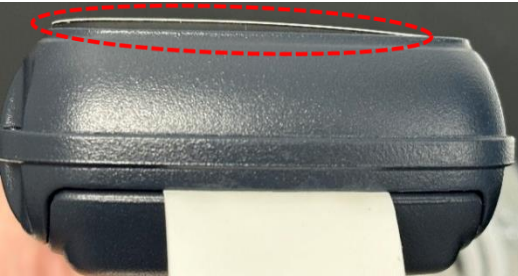
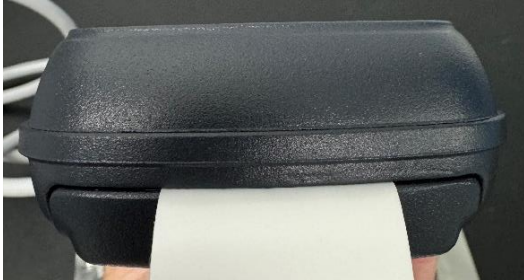
Abbott has identified that there is a potential for the controllers to have a lifted User Interface (UI) membrane that when present, is observed along the edge of the controller housing, near the Display Button as highlighted in images below. The product is not being removed from the field. As of July 8, Abbott has received 4 complaints where a lifted UI membrane was observed by customer with no patient harm reported. It is unlikely that any serious adverse health consequence would occur as a result of the lifted User Interface membrane as detailed below.

If the UI membrane is lifted and if the controller were to be exposed to fluid, there is a potential for fluid ingress into the controller which may lead to damaged Printed Circuit Board Assemblies (PCBA). This could result in unexpected and false positive alarms, as well as loss of the user interface (use of buttons, loss of visual alarms, etc.). Fluid ingress may also lead to loss of power to the pump resulting in a pump stop, however this possibility is very rare due to redundancies in the power path to the pump.

HeartMate 3 System Controller with <u>Lift</u> near the Display Button	HeartMate 3 System Controller with <u>no Lift</u> near the Display Button
Top Edge (close to Display button) View

- Carefully inspect the controller at the edge near the Display Button to confirm that the UI membrane is not lifted (refer to provided visual examples) prior to using the controller or providing the controller to your patient. Do not provide controllers with lifted UI membrane to your patients and report controllers with lifted UI membrane by contacting your local Abbott Representative. Note that controllers that do not present a lifting UI membrane will not lift over time.
