URGENT MEDICAL DEVICE RECALL

HeartMate™ Mobile Power Unit (MPU)
 Model Number: 107758AU
 (191209-WAND-6TQSRJ & WAND 241028-WAND-74DDA2)
 Used with HeartMate™ 3 LVAS Kits (Model Number 106524INT)

March 2025

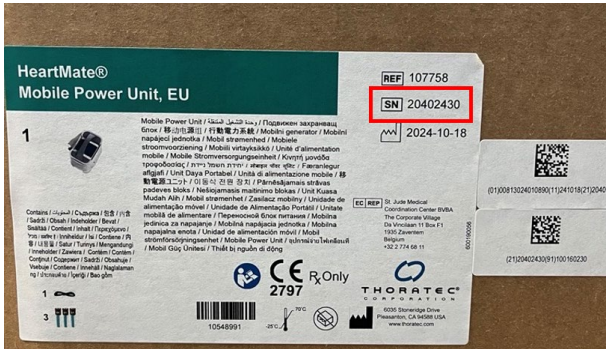
Product Packaging Label

Pictures are for reference only of the Serial Number location (pictures are of EU and US product label examples).
